Historic Preservation Plan

Middletown, Ohio

Adopted by Middletown Historic Preservation Council August 1980

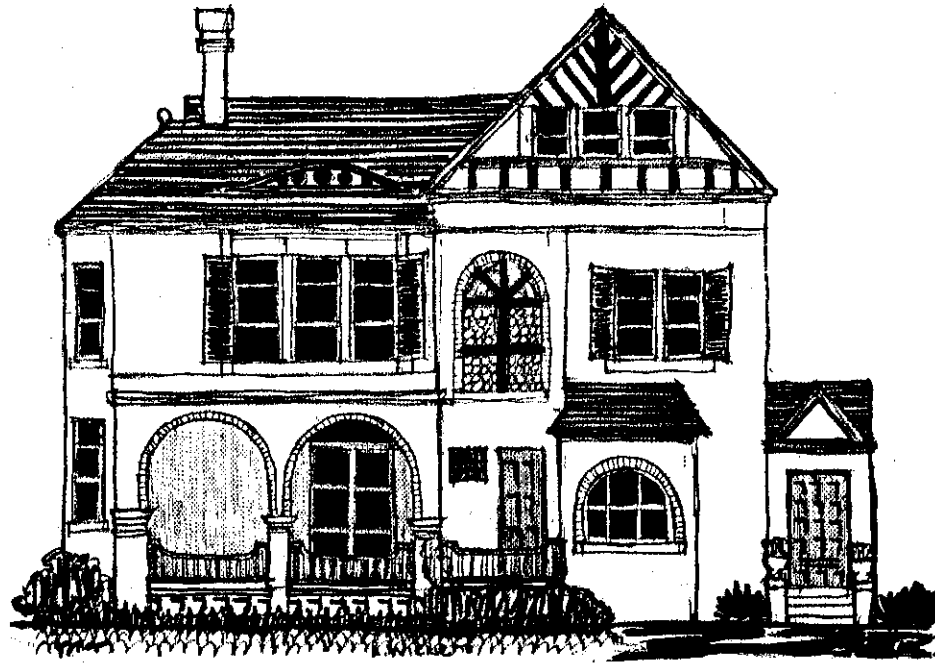
J.B. Tytus Mansion

One of these structures, the Tytus Mansion at 300 South Main, was listed as a National Landmark prior to the district's designation. This Jacobethan style house, built in 1868, was the home of John B. Tytus, Jr. After working in his father's paper mill, he worked for the American Rolling Mill Co. (ARMCO), where in 1927 he applied the method of rolling paper to metal in order to roll sheet steel. This invention revolutionized the steel industry throughout the world.

The building's stone foundation supports walls made of imported red limestone. The roof is constructed of slate with spires, gargoyles, and a griffin along the roof line. The east facade of the building is symmetrical with a dormer directly in the center of the roof above the main entrance. The east facade also features a 3-arch entrance at the porch. Identical turrets with curved glass windows were added to the northeast and southeast corners in 1902. The grounds are surrounded by a limestone wall topped with an iron fence.

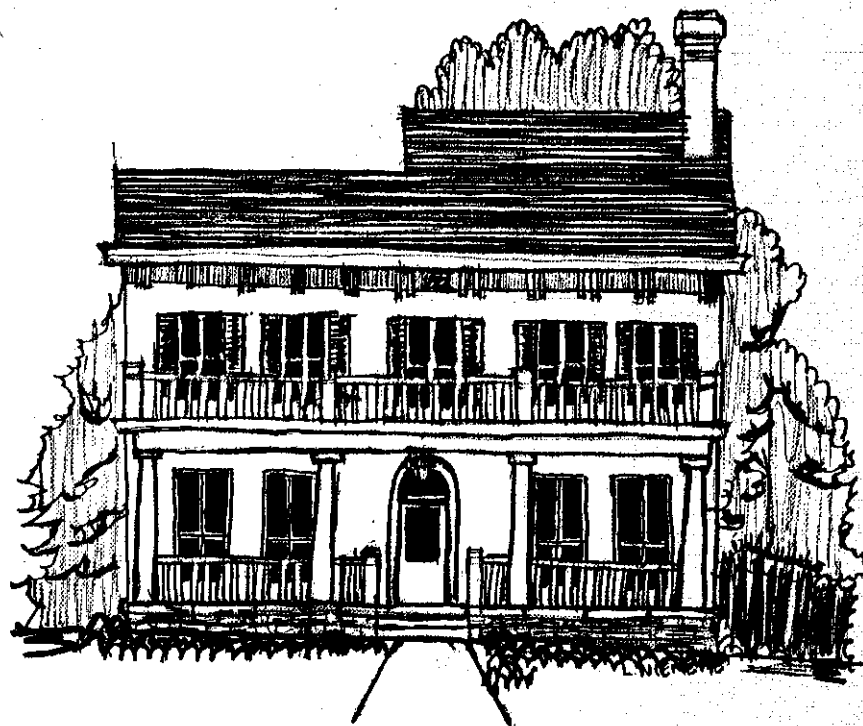
Lefferson Home

The district's oldest building is located on 404 South Main. This Georgian style home of Aurthur Lefferson was built in 1827. Aside from being the oldest house on South

Main, it is the second oldest house in Middletown. The house is set back farther than the other homes on South Main and is surrounded by beautiful landscaping. The exterior walls are made of wood siding and rest on a stone foundation.

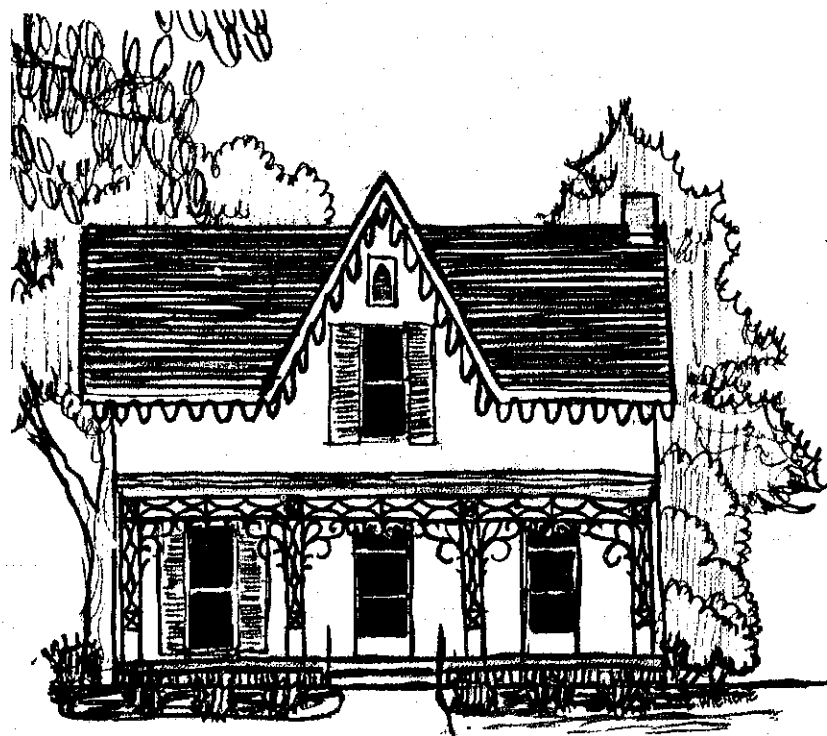
Not all of the homes on South Main are grand mansions. Even those that are not exhibit a great deal of charm and are fine examples of a particular style of architecture. The house at 115 South Main is an excellent example. This Carpenter Gothic home has intricate wood carving on the porch columns and eaves that is unequalled in Middletown.

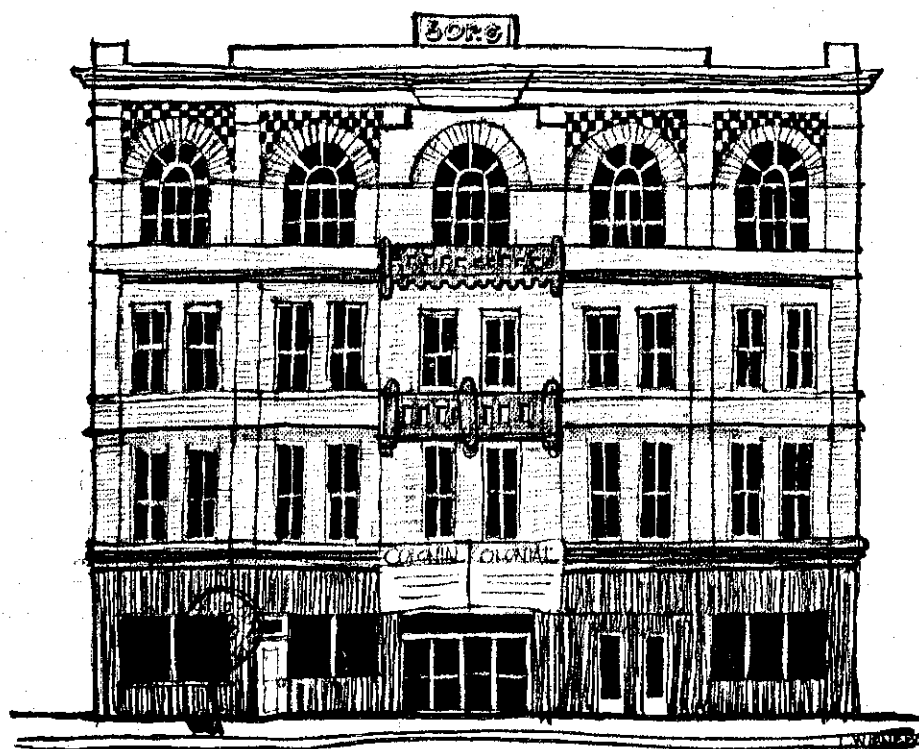
Several commercial structures are located along South Main at the north end of the district. The most prominent of these is the old Sorg Opera House at 53-67 South Main. This structure, built in 1890 has a limestone facade and is of the Romanesque style of architecture. Round arched windows line the fourth floor with red and white limestone patterns above. There is a red limestone balcony off the third story central windows.

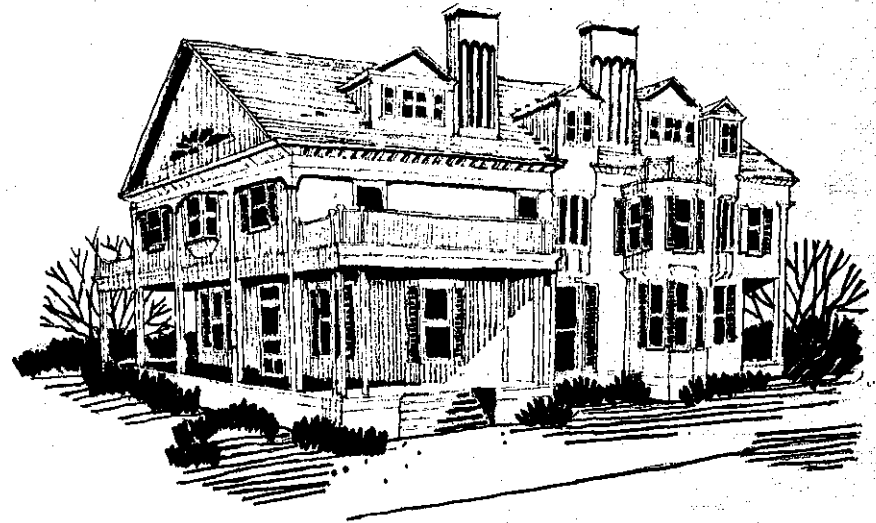
*Place
nsion*

This Greek Revival structure was built as a farmhouse in 1839 by Samuel Bonnell. In 1892 the house was sold to Colin Gardner and remodeled to its present state. Gardner and Francis J. Tytus later started the Gardner Paper Company, now Diamond International.

This 2-1/2 story house of beveled wood siding has a one-story porch that extends around three sides and is supported on slender Doric columns. There are four pilasters on the second story of the north facade which extend down to the porch. The porch on either side is topped with a balustrade. The front windows extend from floor to ceiling. The door projects into the porch space and is flanked by curved beaded glass sidelights. All windows are double hung. There is an Oriel window in the center of the second story. A pediment is supported on a frieze with a row of dentils around it. A semi-elliptical fan window is in the center of this pediment. There is a large bay window on the west side and a small bay on the east side. There are two chimneys on both the east and west sides of the house with dormers between.

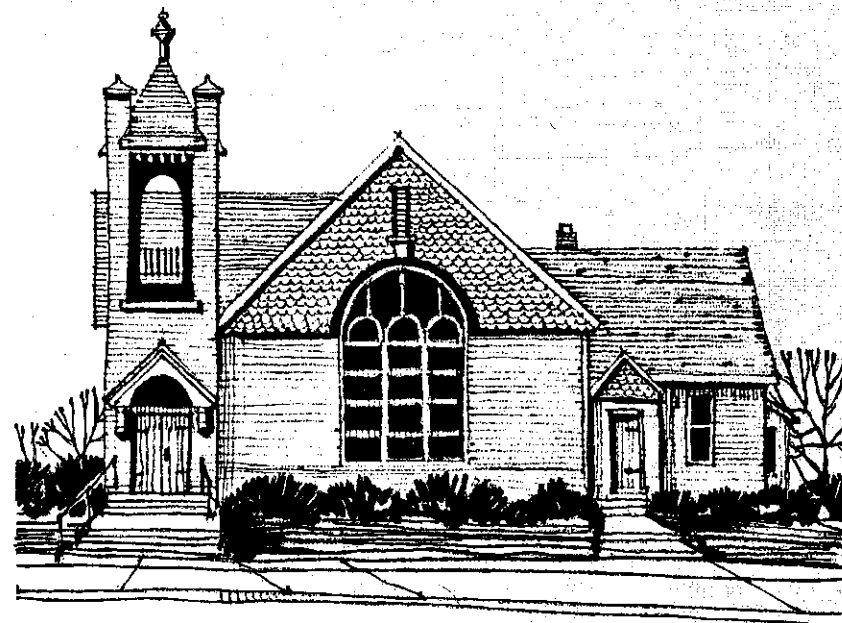
8. 1412 Girard Avenue
Freewill Baptist Church

This shingle style structure was built in 1898 as the United Presbyterian Church. In 1960 the members of this church merged with the Oakland Presbyterian Church. After constructing a new church in 1962, this church was sold and is presently owned by the Freewill Baptist Church.

The church has a rock faced foundation. The lower portion of the walls has beveled siding and the upper portion has imbricated wood shingles. It has a gable roof with asphalt shingles. The windows are of stained glass with round arches. A square bell tower is located at the northeast corner of the church with round arched opening at the top.

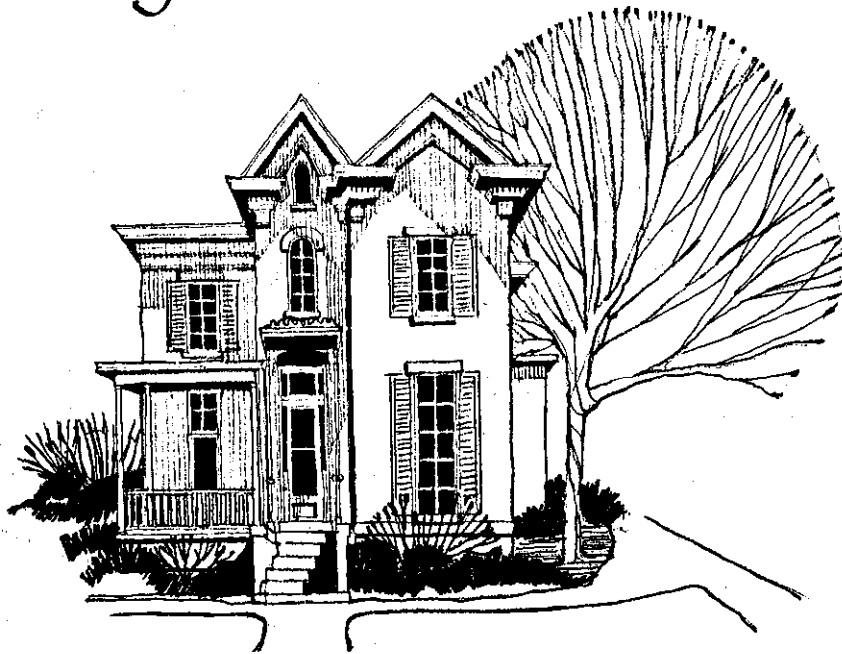
9. 403 Curtis Street
Doty House

This Victorian Italianate house was built in 1860 by Lorenzo Dow Doty, grandson of Daniel Doty, who had been Middletown's first settler. Lorenzo Dow Doty was mayor of Middletown in 1854 and 1858.

The house is built on a limestone foundation with a smooth sandstone water table. The walls are of brick and all lintels and lug sills are sandstone. The windows are 4/4 and 4/6 double hung. At the northwest corner of the house is a wooden porch with Doric columns and balustrade. Another porch is located at the center of the west side of the house. This is constructed of cast iron. Dentils appear on the frieze below the cornice.

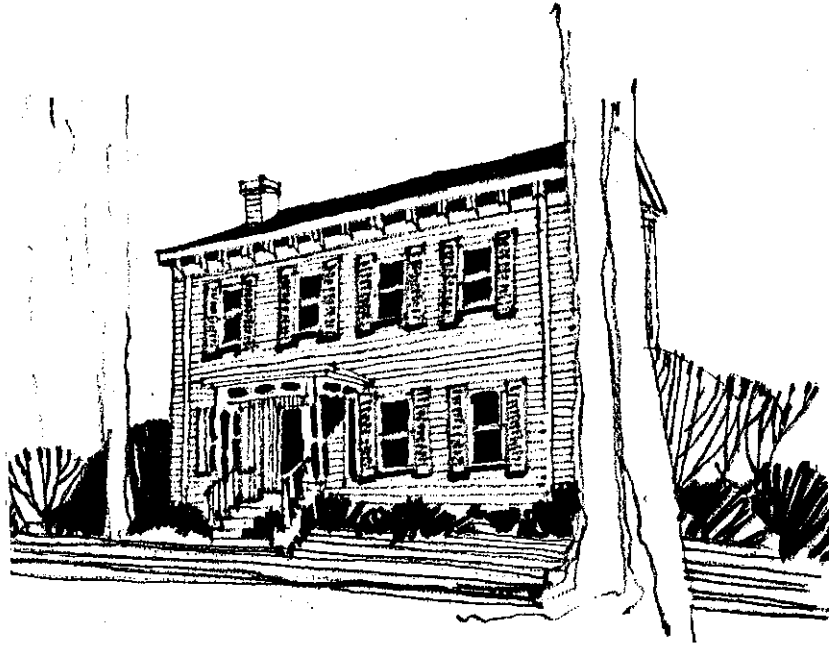
13. 3515 Central Avenue
Cole House

Built around 1850, this Federal style house is set-back nearly 200 feet amidst mature trees. The house was first occupied by the Stephen Cole family. During the Depression, the house was converted to a two-family residence. It has since been restored to a single-family home.

The 2-story frame house with horizontal wood siding is resting on a stone foundation. The front porch is made of concrete. The columns and cornice at the porch roof are beautifully detailed in wood. The gable roof of the house is surrounded by a bracketed cornice. All of the windows are double hung with an entablature at the head of each. A brick chimney rises approximately two feet above the roof on the west side of the house.

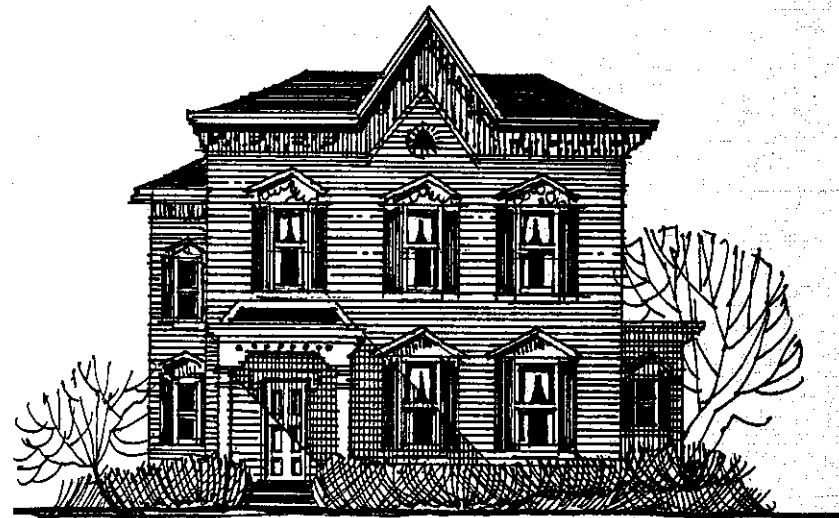
Lane

This Victorian-Italianate residence was originally a country farmhouse.

The brick house is resting on a foundation of cut stone. The hip roof with a steeply pitched gable in front is made of slate. All of the windows are double hung with intricately detailed metal hood molds. A metal cornice of ornamental brackets and highly detailed frieze panels surrounds the roof. The ornamental porch roofs as well as the columns supporting them are also made of metal.

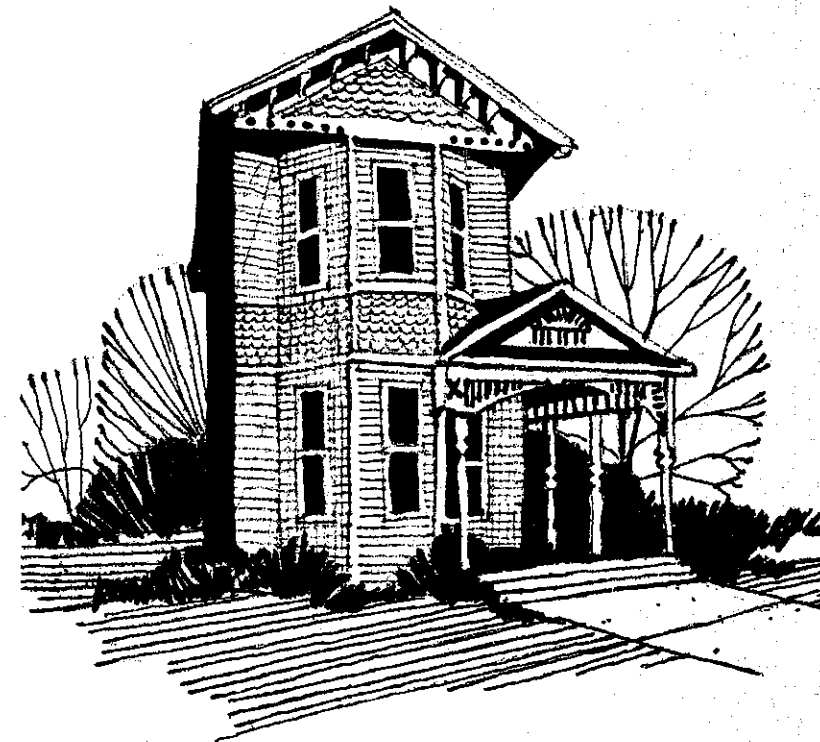
Common Building Type

The building type that is most plentiful is that style which is shown in the sketch above. This style of residence can be found in scattered locations throughout the older neighborhoods of the City. The best example of a restored house of this style is at 808 South Main Street. Common elements that are present in these structures give them their unique character and charm. They are as follows:

- L-shape plan is most common. T-shape plan is occasionally found.
- Two-stories.
- Gable roofs.
- Large porch on the side of the house. In the case of a T-shape plan, a porch is located on both sides of the house. Occasionally, the porch is continued in the front of the house.

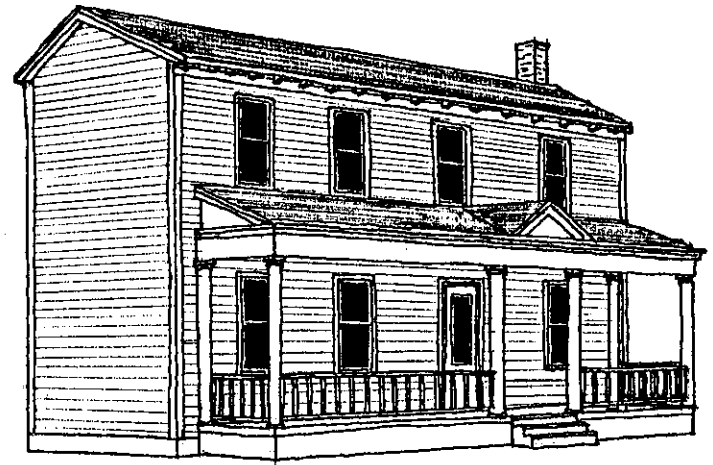
- Rectangular plan shape, with the short end usually facing the front.
- 1-1/2 stories.
- Low sloping gable roof which extends over the porch.
- Large porch extends across the entire front of the house.
- Windows are double hung at a vertical 2/1 ratio.
- Exterior walls are of horizontal wood siding. Brick is very seldom used.
- Dormer wall is always of horizontal wood siding.
- Exposed rafters (no cornice).
- Rectangular columns and solid wall as porch railing are both covered with the same material as the house (horizontal wood siding).

A common variation of this style is a rectangular plan shape with a gable roof.

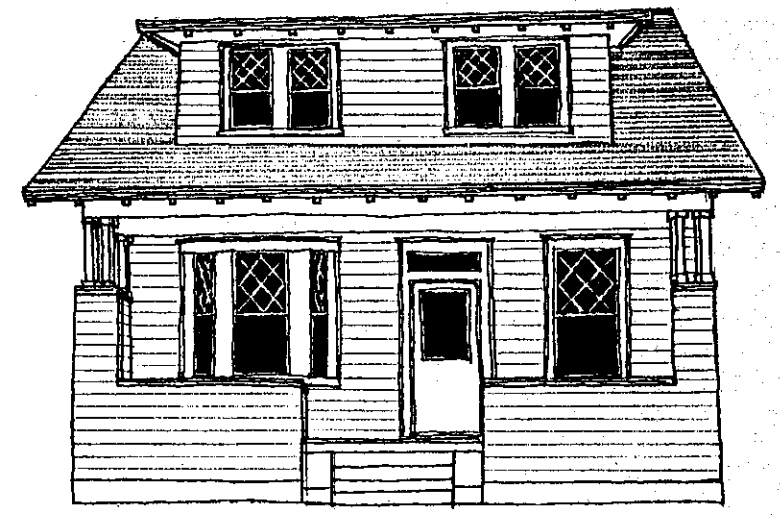
Type IV

Another building type that is common in older Middletown neighborhoods is illustrated in this sketch of 216 Baltimore Street, one of its best examples. The following characteristics are common to the style.

- Square plan shape with offsets.
- 2-1/2 stories.
- Hip roof with gable roof at protusions.
- Porch extends across the entire front of the house.
- Hip roof on porch.
- Pediment is always at porch roof above steps.
- Exterior walls of horizontal wood siding.
- Broad banding circles the house just above the first floor.
- Waved siding is sometimes used at gables and banding.
- Double hung windows, at 2/1 ratio, emphasize the vertical.
- Shutters are sometimes used.
- Small windows in pediment at the third floor.
- The porch roof is usually supported by Doric columns.
- The porch railing is of closely spaced wood spindle posts.

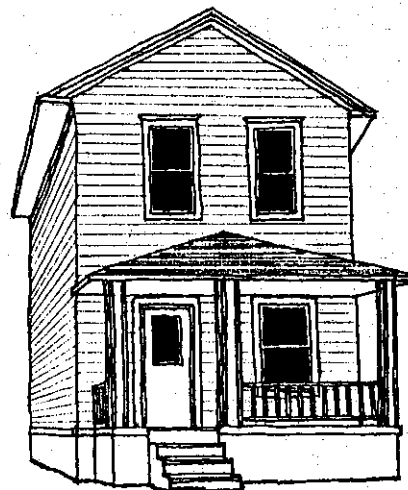
Although seldom ornate, this building style is very plentiful and adds a great deal of charm to the older neighborhoods of the City. This is illustrated by the house at 315 Crawford Street. The characteristics of this style are:

- Rectangular plan shape with the short end facing the front.
- 2-stories.
- Gable roof.
- Porch extends across the front of the house.
- Windows are double hung at a 2/1 vertical ratio.
- Shutters are common.
- Wood siding is the usual wall material.
- Porch columns and railings may vary from the spindle type to square columns with a solid wall at railing height. This solid wall is covered with wood siding.

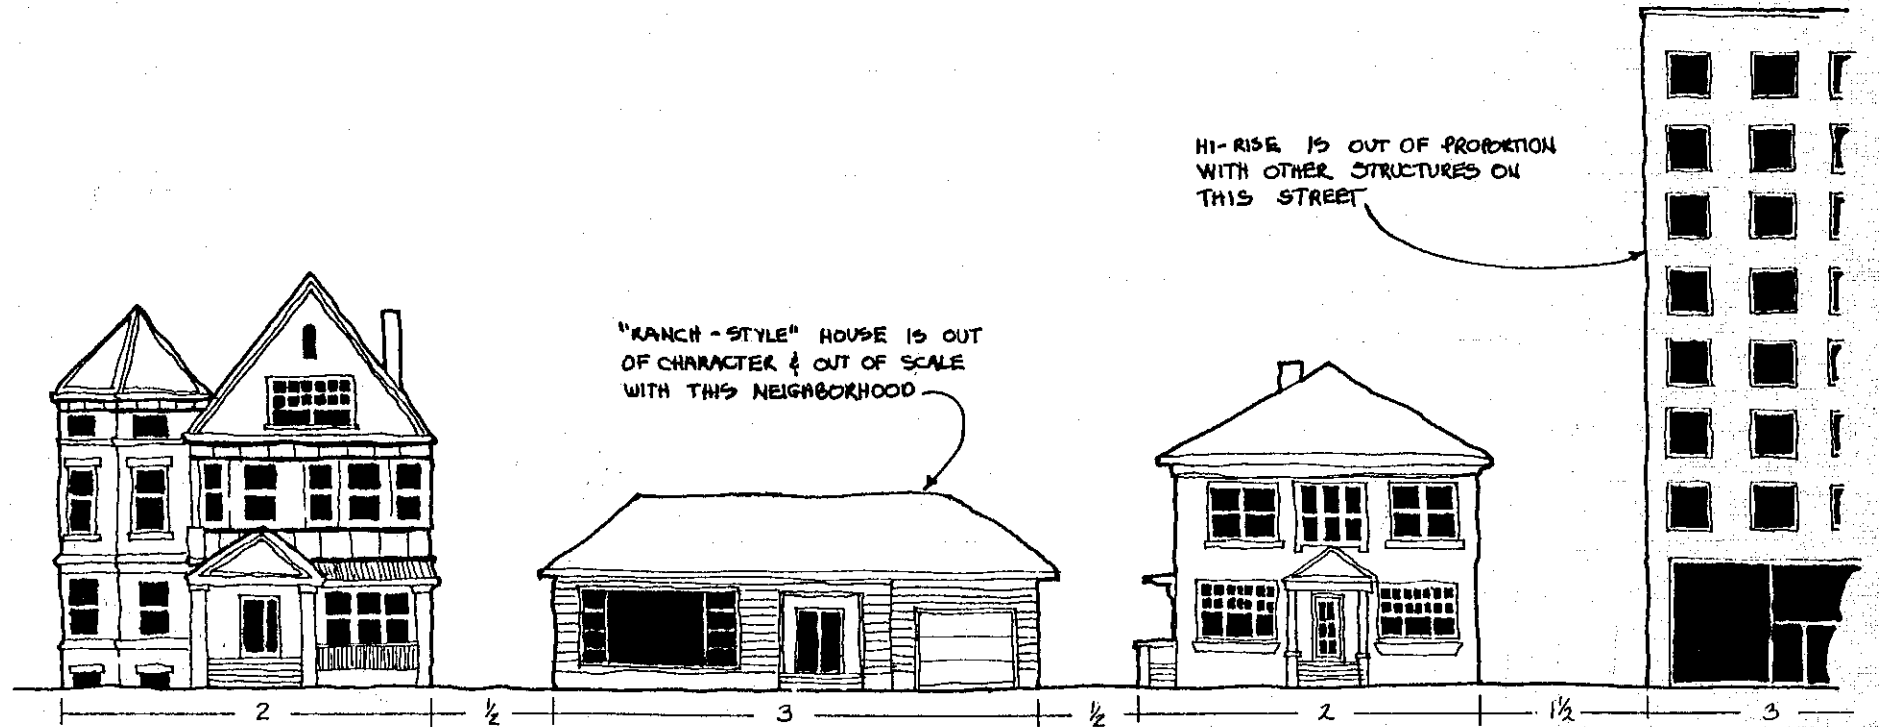
NO NEW "MODERN" CONSTRUCTION CAN SOMETIMES DESTROY THE HARMONY & SCALE OF A NEIGHBORHOOD. THE 2/1 RATIO OF BUILDING MASS AND SPACE HAS BEEN DESTROYED BY THE PLACEMENT OF THE "RANCH-STYLE" HOUSE.

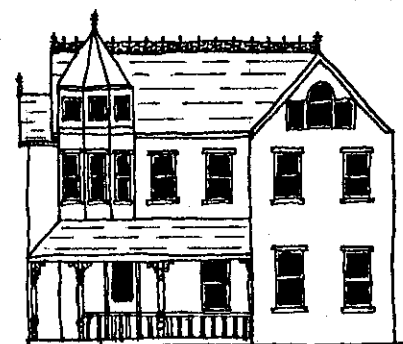
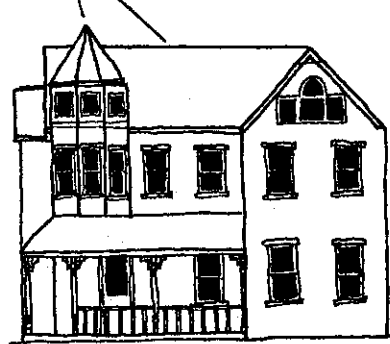
- Preserve or replace, where necessary, all architectural features which give the roof its essential character such as dormer windows, cupolas, cornices, brackets, chimneys, cresting and weather vanes.

WHEN THE CRESTING &
FINIALS WERE REMOVED,
SOME OF THE BUILDING'S
CHARACTER WENT WITH
THEM.

Don't - strip the roof of architectural features important to its character.

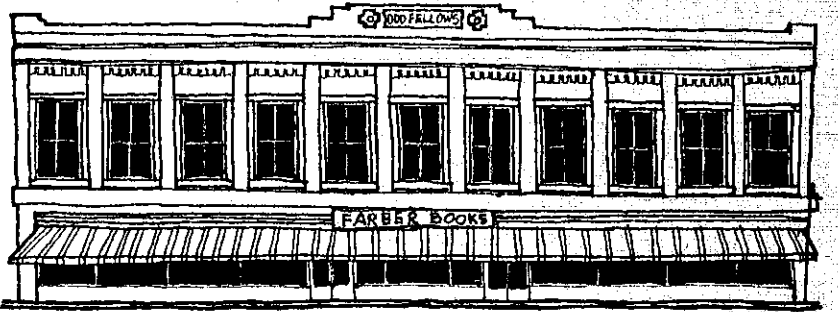
NO SIGN IS SO LARGE THAT IT COVERS A PORTION OF THE 2ND FLOOR WINDOWS.

SMALLER, MORE ATTRACTIVE SIGN ALLOWS WINDOWS TO BE REOPENED.

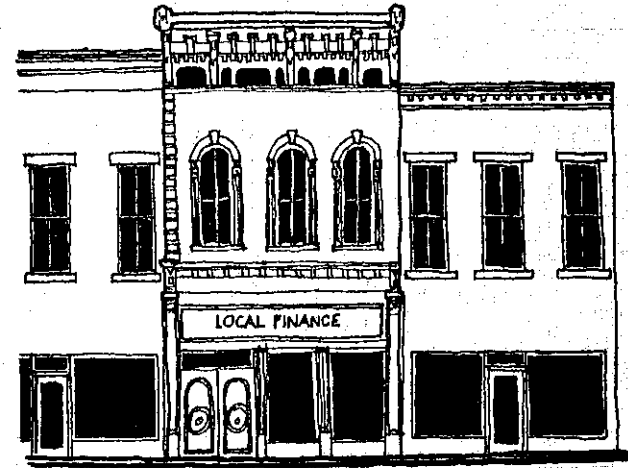
- A sign may be located in the display window if it is well designed and is a decal type of sign.

SIMPLE, WELL DESIGNED
SIGN IN WINDOW
