Historic Preservation Plan

Middletown, Ohio

Adopted by Middletown Historic Preservation Council August 1980

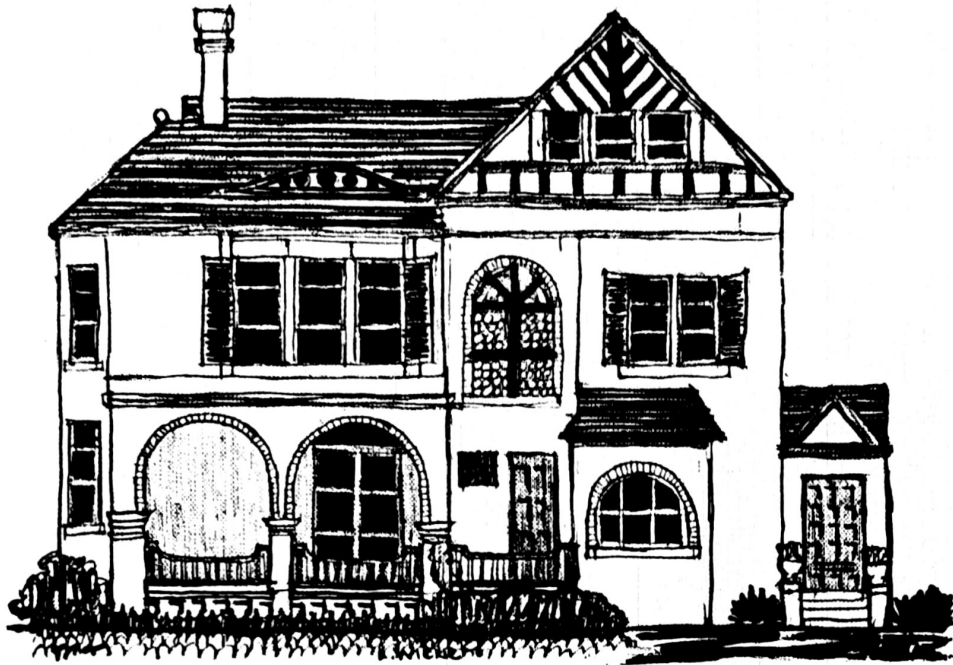
J.B. Tytus Mansion

One of these structures, the Tytus Mansion at 300 South Main, was listed as a National Landmark prior to the district's designation. This Jacobethan style house, built in 1868, was the home of John B. Tytus, Jr. After working in his father's paper mill, he worked for the American Rolling Mill Co. (ARMCO), where in 1927 he applied the method of rolling paper to metal in order to roll sheet steel. This invention revolutionized the steel industry throughout the world.

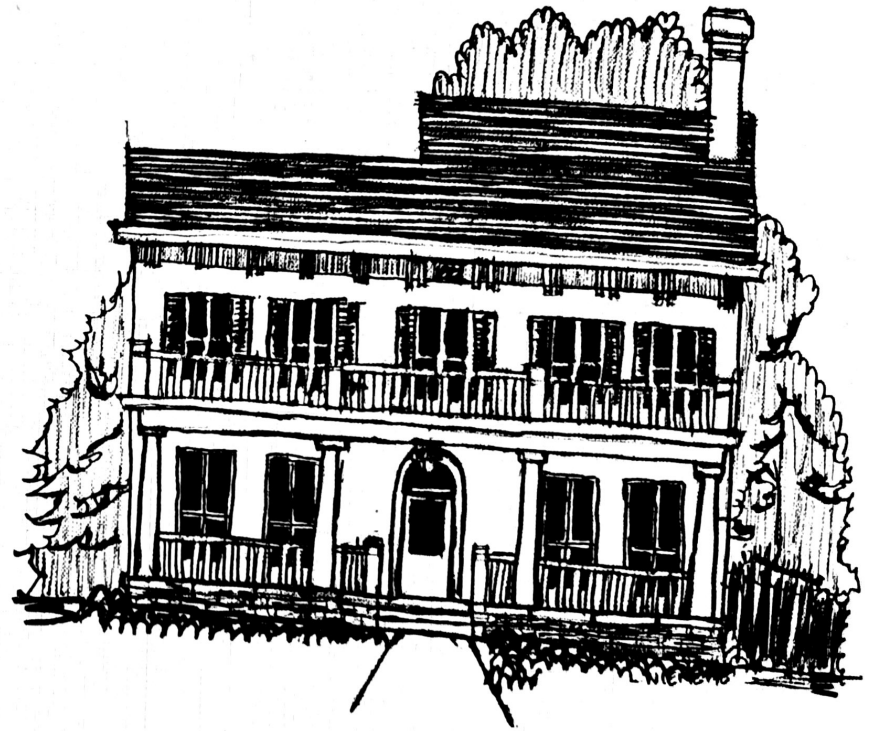
Lefferson Home

The district's oldest building is located on 404 South Main. This Georgian style home of Aurthur Lefferson was built in 1827. Aside from being the oldest house on South

Main, it is the second oldest house in Middletown. The house is set back farther than the other homes on South Main and is surrounded by beautiful landscaping. The exterior walls are made of wood siding and rest on a stone foundation.

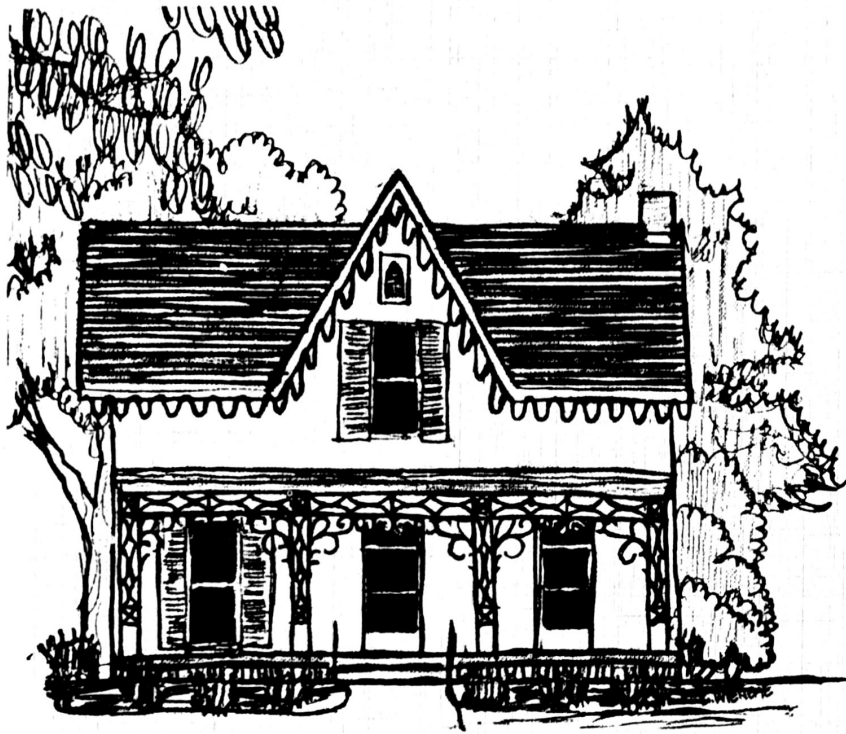
Not all of the homes on South Main are grand mansions. Even those that are not exhibit a great deal of charm and are fine examples of a particular style of architecture. The house at 115 South Main is an excellent example. This Carpenter Gothic home has intricate wood carving on the porch columns and eaves that is unequalled in Middletown.

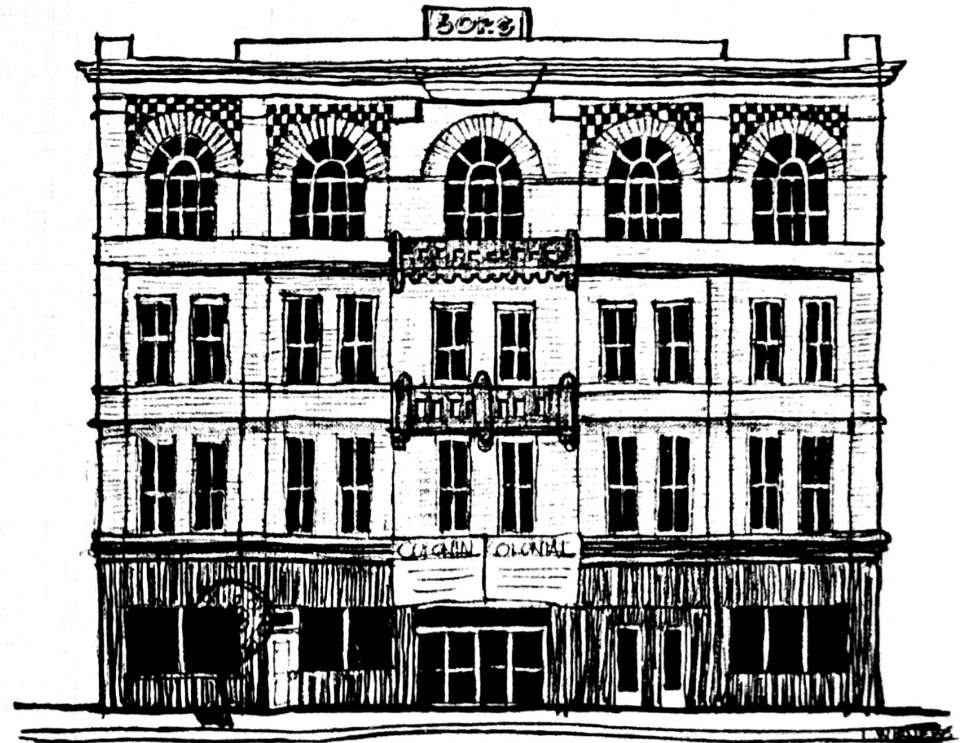
Several commercial structures are located along South Main at the north end of the district. The most prominent of these is the old Sorg Opera House at 53-67 South Main. This structure, built in 1890 has a limestone facade and is of the Romanesque style of architecture. Round arched windows line the fourth floor with red and white limestone patterns above. There is a red limestone balcony off the third story central windows.

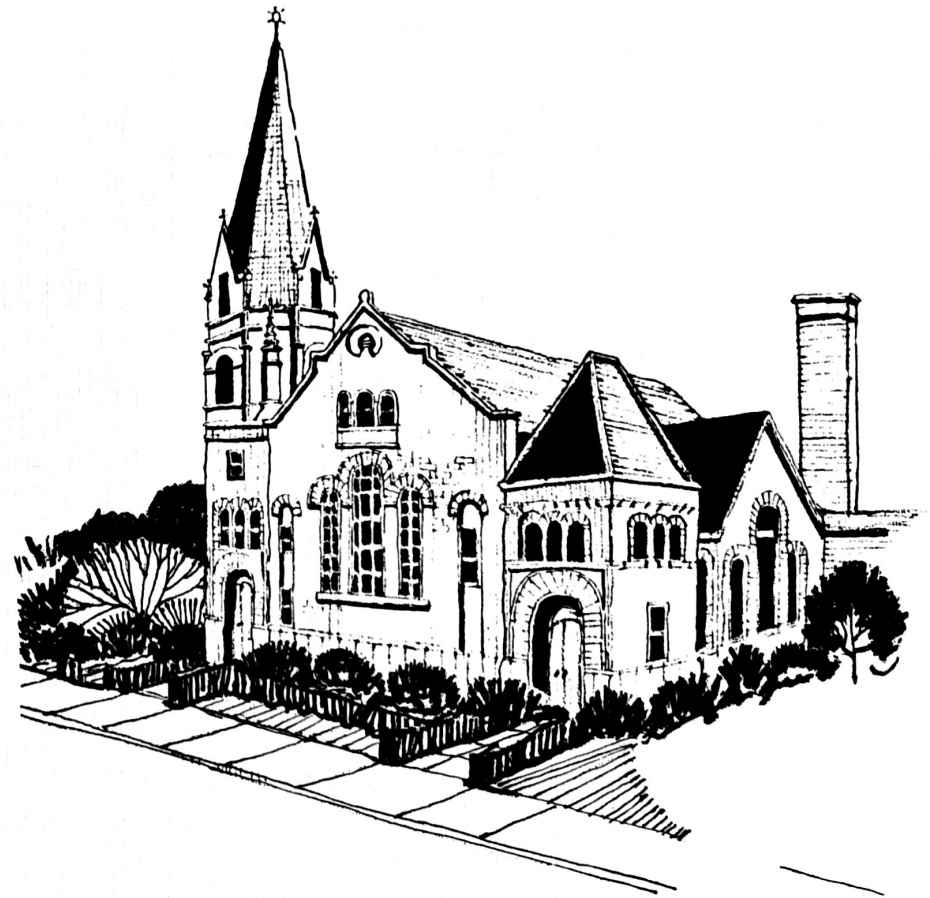
*First United
Methodist Church*

At the south end of the district is the First United Methodist Church. This Romanesque Revival church, built in 1890, was the first stone church in Middletown. Samuel A. Hannaford and Sons were hired as the architects. This firm had designed a number of important public buildings in Cincinnati, including Music Hall.

The sandstone structure is resting on a foundation of limestone. The doors at the front entrance are round arched and made of oak. There are two-story stained glass windows on three sides of the sanctuary.

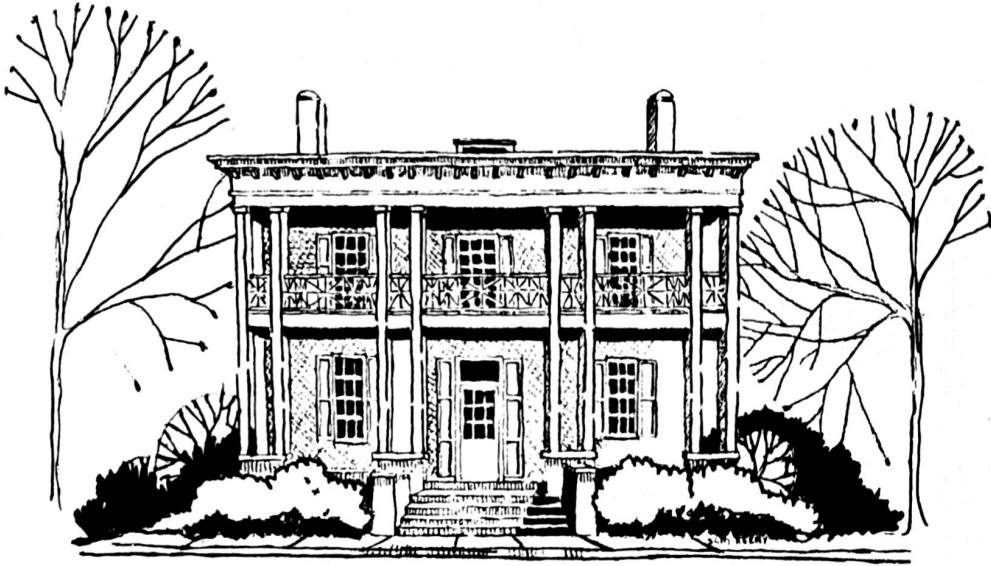
1. 1353 Avalon Drive Tytus Home

The brick house is built on a stone foundation with a stone water table. The south facade has a 2-story porch with paired square supports. All of the windows are 6/6 double hung with stone sills and lintels. The hip roof is constructed of standing seam metal. Two brick chimneys are located on both the east and west sides of the house.

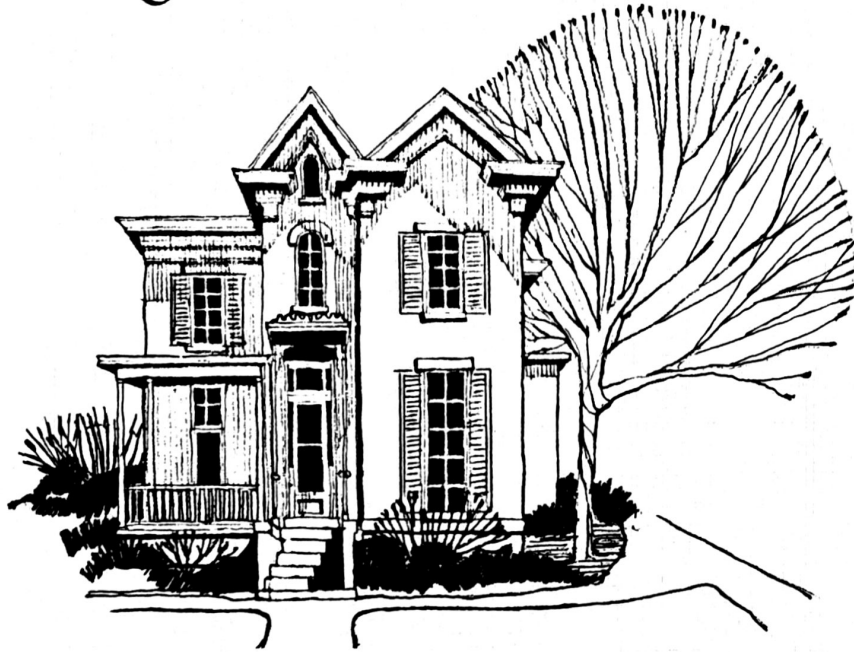
9. 403 Curtis Street
Doty House

The house is built on a limestone foundation with a smooth sandstone water table. The walls are of brick and all lintels and lug sills are sandstone. The windows are 4/4 and 4/6 double hung. At the northwest corner of the house is a wooden porch with Doric columns and balustrade. Another porch is located at the center of the west side of the house. This is constructed of cast iron. Dentils appear on the frieze below the cornice.

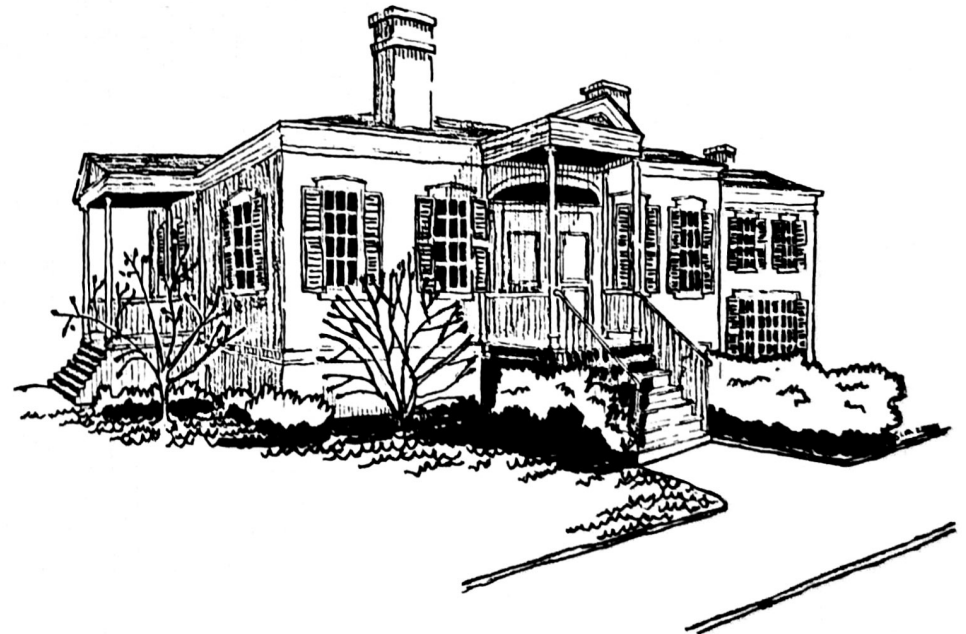
13. 3515 Central Avenue
Cole House

The 2-story frame house with horizontal wood siding is resting on a stone foundation. The front porch is made of concrete. The columns and cornice at the porch roof are beautifully detailed in wood. The gable roof of the house is surrounded by a bracketed cornice. All of the windows are double hung with an entablature at the head of each. A brick chimney rises approximately two feet above the roof on the west side of the house.

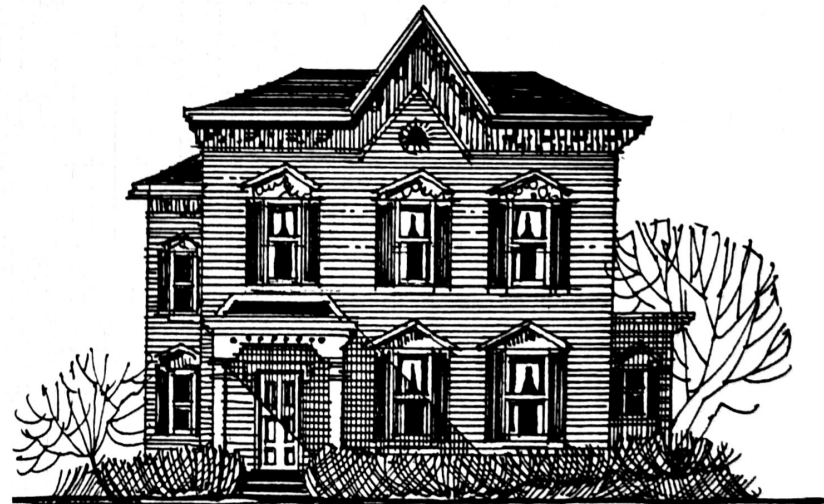
Type I

The building type that is most plentiful is that style which is shown in the sketch above. This style of residence can be found in scattered locations throughout the older neighborhoods of the City. The best example of a restored house of this style is at 808 South Main Street. Common elements that are present in these structures give them their unique character and charm. They are as follows:

- L-shape plan is most common. T-shape plan is occasionally found.
- Two-stories.
- Gable roofs.
- Large porch on the side of the house. In the case of a T-shape plan, a porch is located on both sides of the house. Occasionally, the porch is continued in the front of the house.

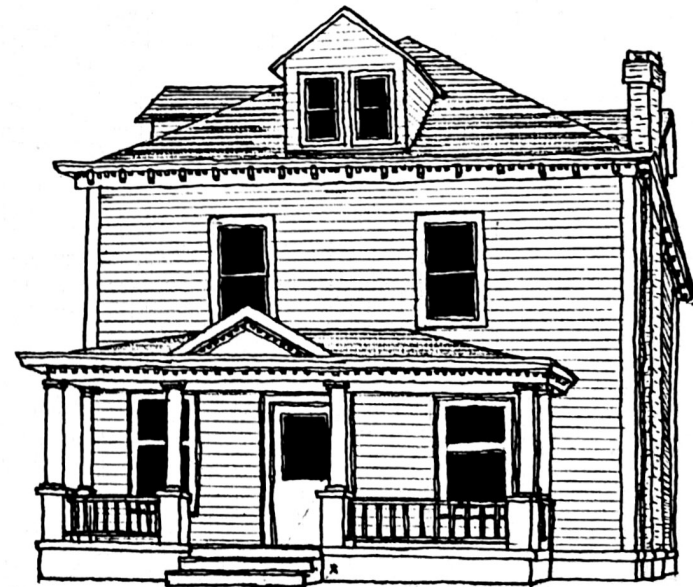
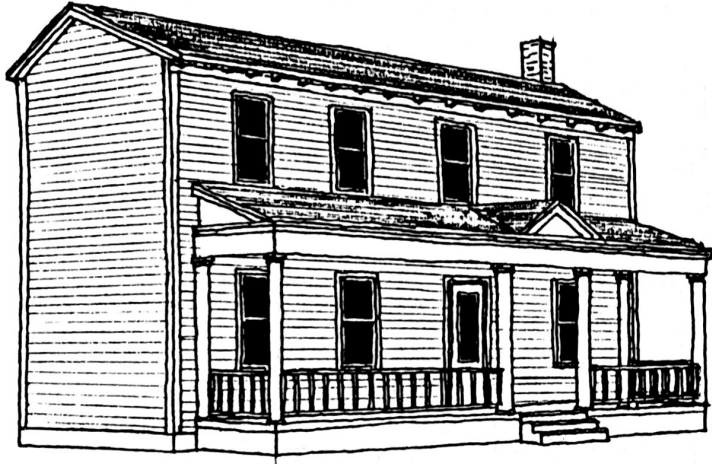
A more recent style of house that is common to Middletown's older neighborhoods is that which is shown in the sketch. The house at 219 Yankee Road is one example of a residence of this type. Common elements of this style are as follows:

- Square plan shape.
- 2-1/2 stories.
- Hip roof.
- Dormers with hip or gable roof.
- Large porch that extends across the entire front of the house.
- Hip style porch roof is most common. Occasionally, it is flat.
- Pediment is seldom located at porch roof above front steps.
- Horizontal wood siding is the most common material of exterior walls. Occasionally, this material is brick.
- Windows are double hung at a vertical 2/1 ratio.
- Very little, or no, detailing.
- Bracketed cornice with dentils is the only detailing found.

- Doric columns support porch roof.
- Columns are usually resting on stone or brick pedestals.
- If porch railing is present, it is of closely spaced spindle posts.

A common variation of this style is a rectangular plan shape with a gable roof.

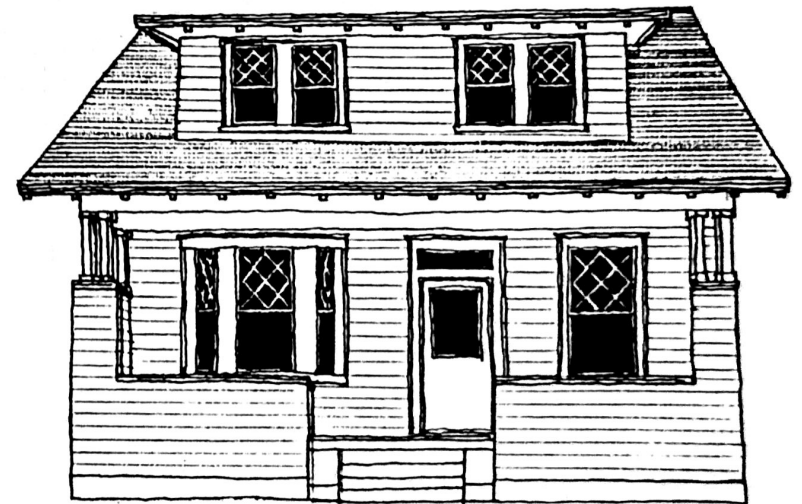
Type III

The sketch shows another common house style of a more recent period of Middletown's architectural history. 235 Vanderveer Street is one of the many examples of this building type, which is suggestive of the Bungalow style. The common characteristics are:

- Rectangular plan shape, with the short end usually facing the front.
- 1-1/2 stories.
- Low sloping gable roof which extends over the porch.
- Large porch extends across the entire front of the house.
- Windows are double hung at a vertical 2/1 ratio.
- Exterior walls are of horizontal wood siding. Brick is very seldom used.
- Dormer wall is always of horizontal wood siding.
- Exposed rafters (no cornice).
- Rectangular columns and solid wall as porch railing are both covered with the same material as the house (horizontal wood siding).

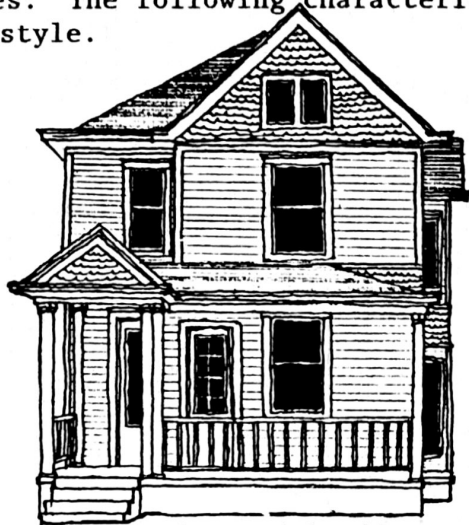
Another building type that is common in older Middletown neighborhoods is illustrated in this sketch of 216 Baltimore Street, one of its best examples. The following characteristics are common to the style.

- Square plan shape with offsets.
- 2-1/2 stories.
- Hip roof with gable roof at protusions.
- Porch extends across the entire front of the house.
- Hip roof on porch.
- Pediment is always at porch roof above steps.
- Exterior walls of horizontal wood siding.
- Broad banding circles the house just above the first floor.
- Waved siding is sometimes used at gables and banding.
- Double hung windows, at 2/1 ratio, emphasize the vertical.
- Shutters are sometimes used.
- Small windows in pediment at the third floor.
- The porch roof is usually supported by Doric columns.
- The porch railing is of closely spaced wood spindle posts.

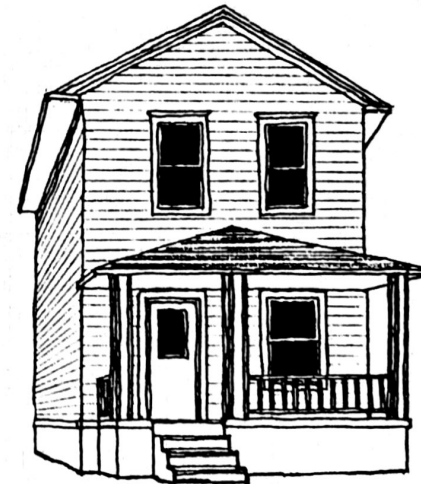
Although seldom ornate, this building style is very plentiful and adds a great deal of charm to the older neighborhoods of the City. This is illustrated by the house at 315 Crawford Street. The characteristics of this style are:

- Rectangular plan shape with the short end facing the front.
- 2-stories.
- Gable roof.
- Porch extends across the front of the house.
- Windows are double hung at a 2/1 vertical ratio.
- Shutters are common.
- Wood siding is the usual wall material.
- Porch columns and railings may vary from the spindle type to square columns with a solid wall at railing height. This solid wall is covered with wood siding.

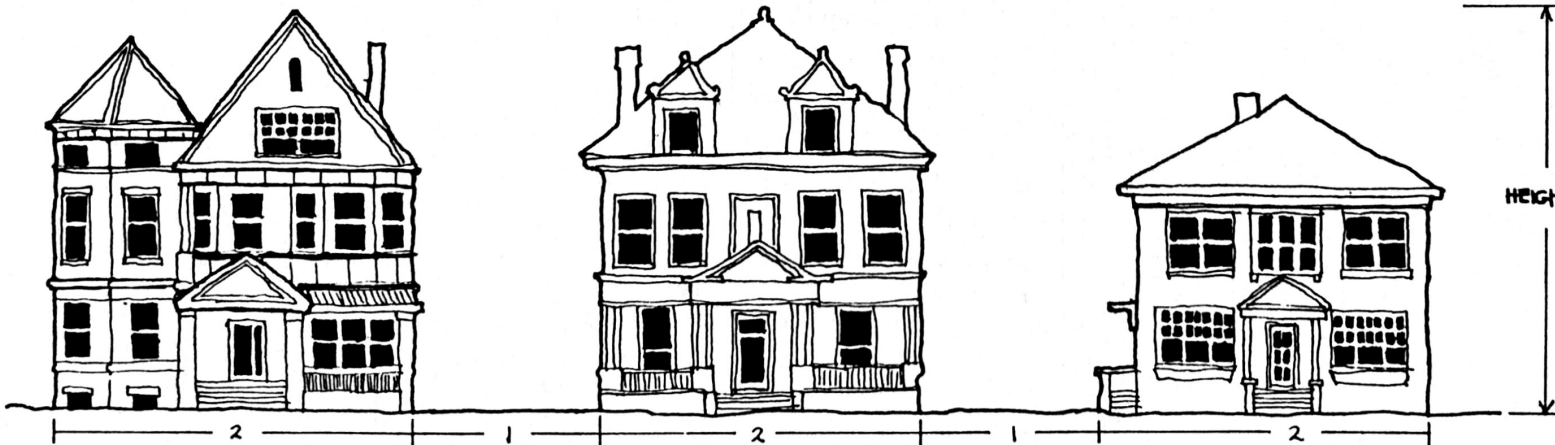
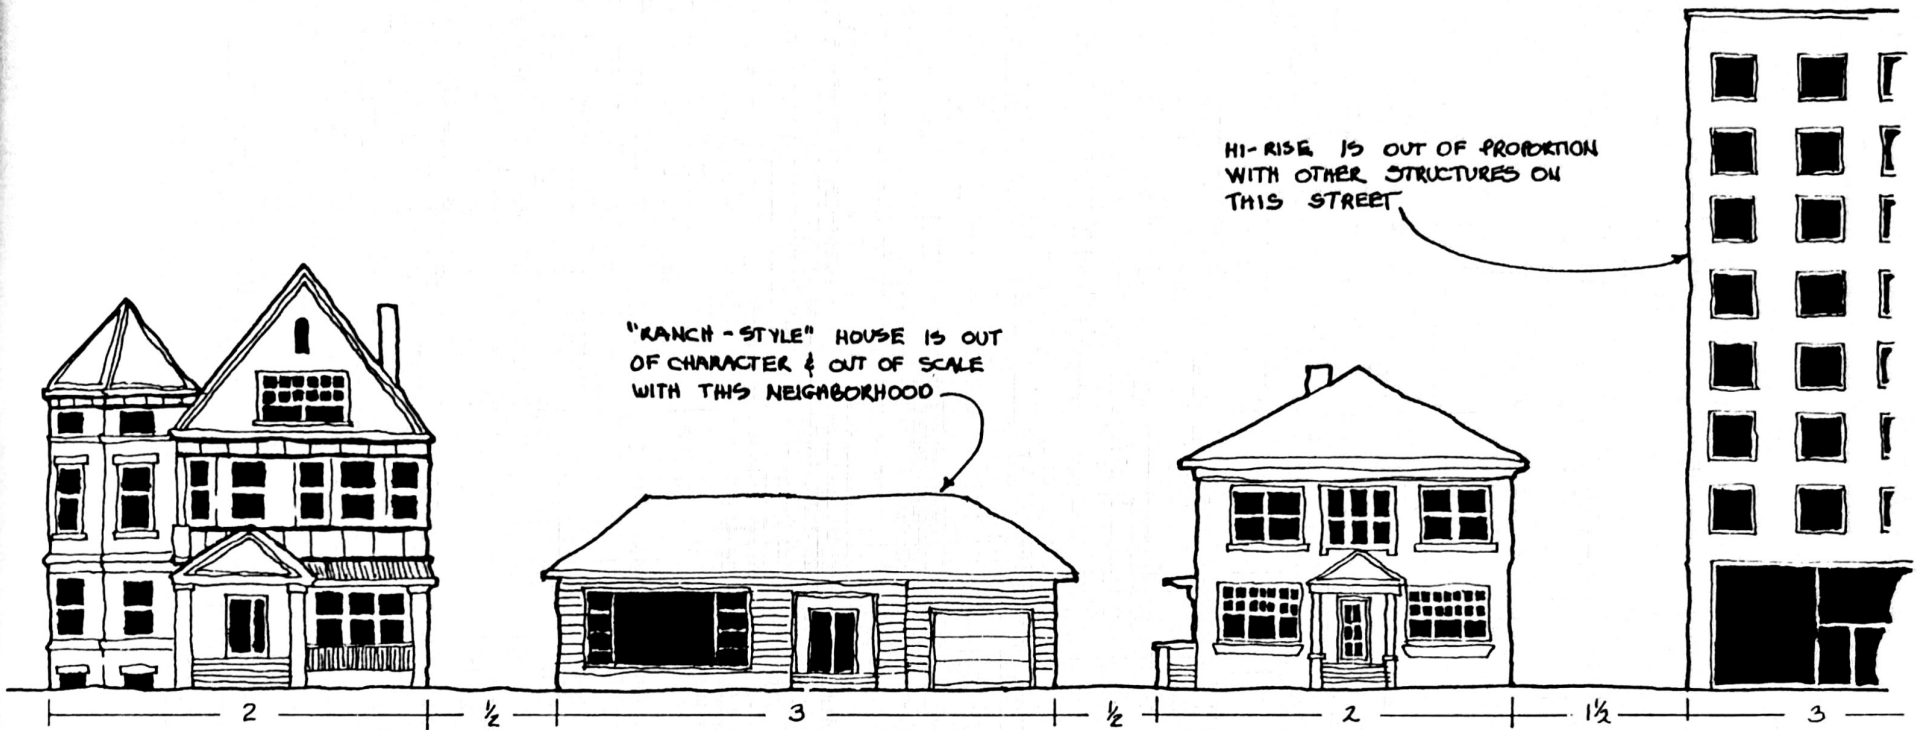
YES

RHYTHM - A PLEASING SEQUENCE OF BUILDING MASSES & SPACES EXPERIENCED WHILE TRAVELING DOWN THE STREET

NO

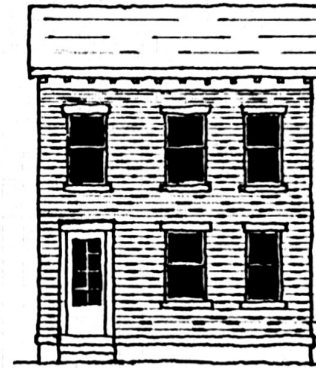
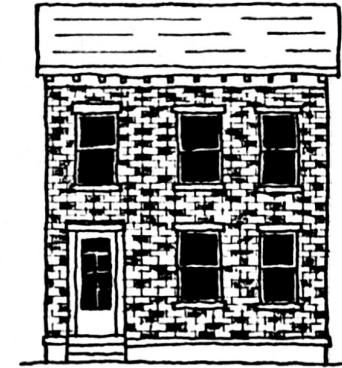
YES

NO INAPPROPRIATE MATERIAL.

NEVER USE BRICKS THAT GIVE A PHONEY "RUSTIC" EFFECT - BRICKS OF HIGHLY CONTRASTING COLORS AND TONES. THIS ONLY GIVES A CHECKERBOARD LOOK, NOT THE LOOK OF AN OLD WALL.

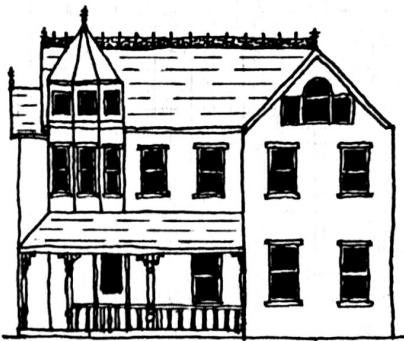
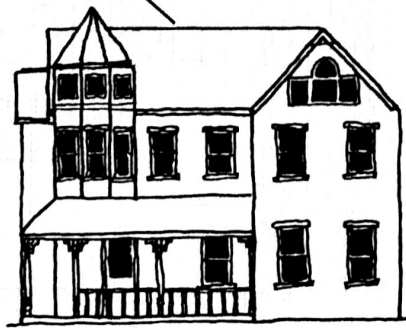
WHEN THE CRESTING & FINIALS WERE REMOVED, SOME OF THE BUILDING'S CHARACTER WENT WITH THEM.

YES

NO

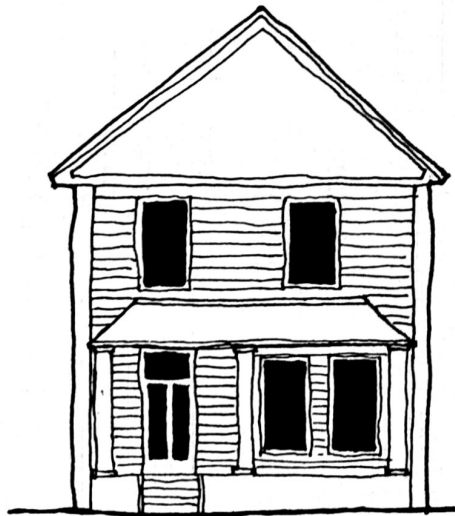
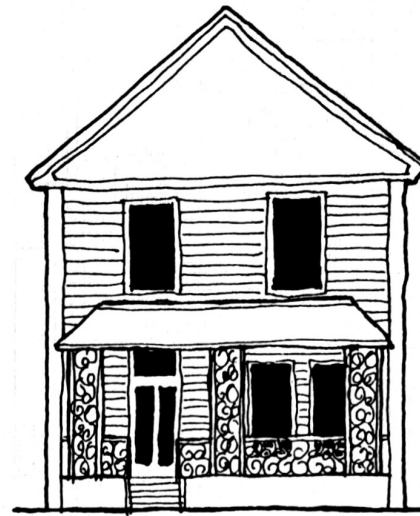
YES

ORIGINAL PORCH
AND ENTRANCE

NO

ORIGINAL PORCH
COLUMNS REPLACED BY
METAL GRILL-LIKE
COLUMNS & RAILINGS.
OUT-OF-CHARACTER
WITH STYLE OF HOUSE!

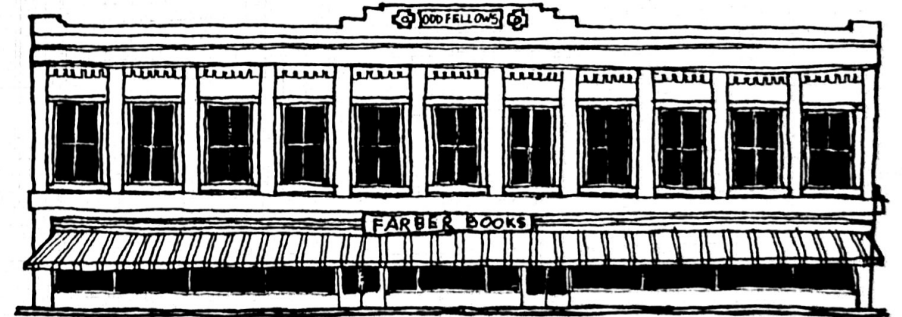
SMALLER, MORE ATTRACTIVE SIGN ALLOWS WINDOWS TO BE REOPENED.

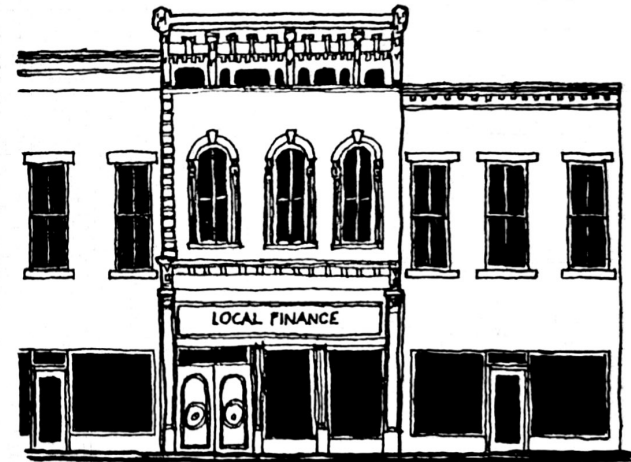
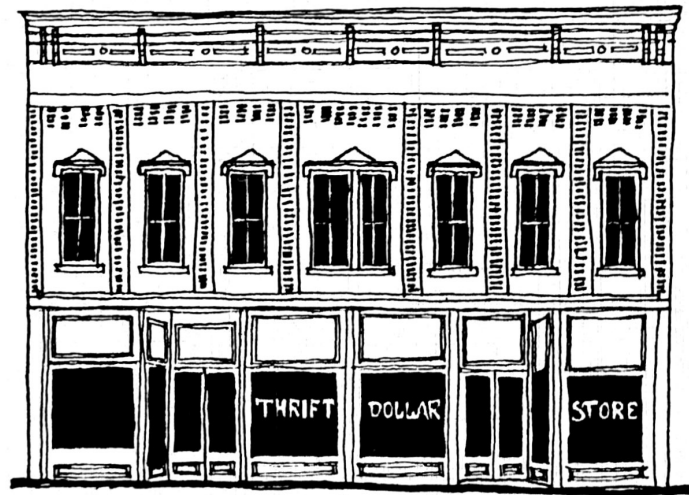
YES

- A sign may be located in the display window if it is well designed and is a decal type of sign.

SIMPLE, WELL DESIGNED
SIGN IN WINDOW
